Rental Minimum Standards Check Report

Type of Report: Rental Minimum Standards Check

APBI

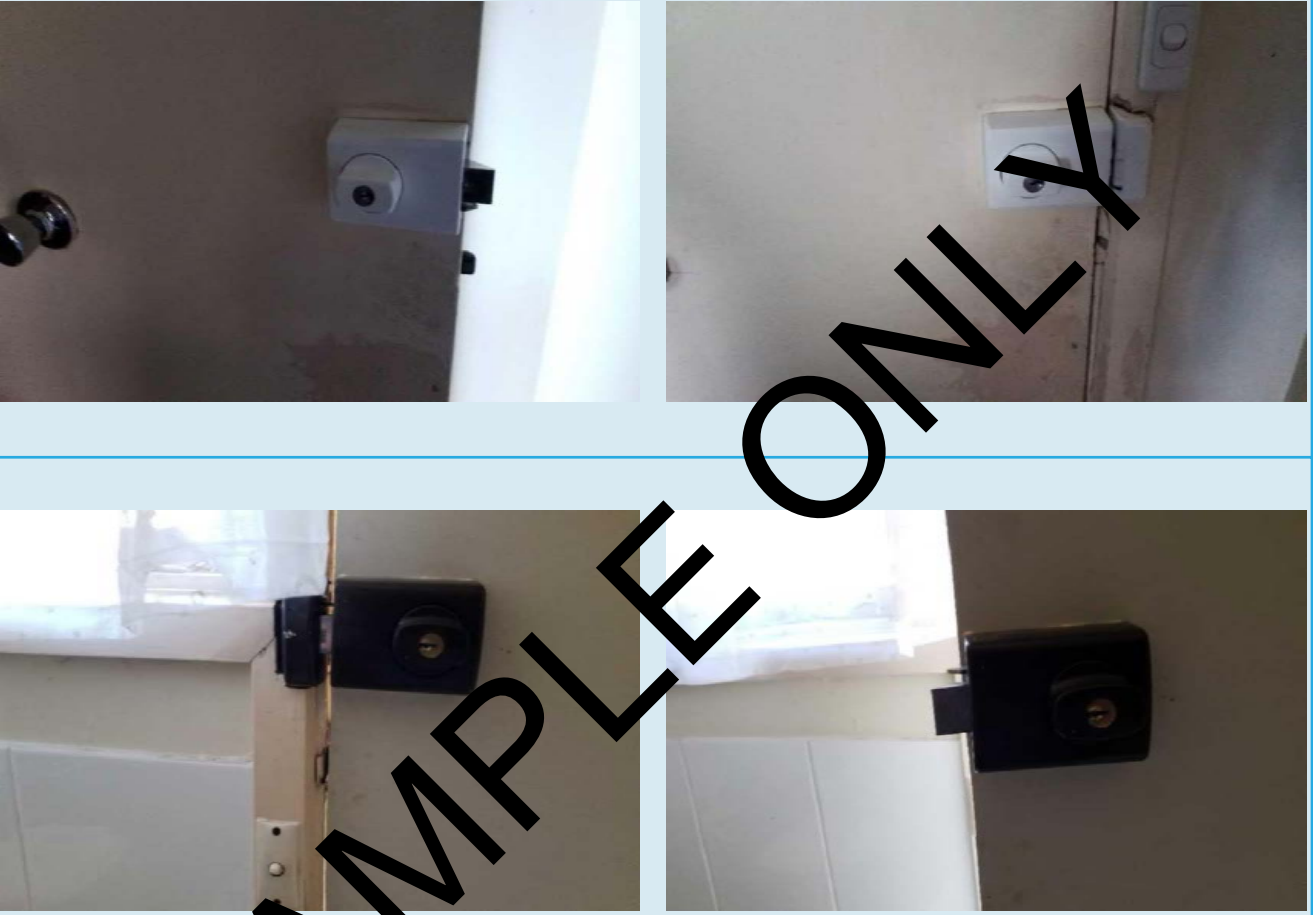
5. Door Locks

Door Locks	
Requirement Met	Throughout
Comments	
All external entry doors are operated by a key from the outside & lockable from the inside.

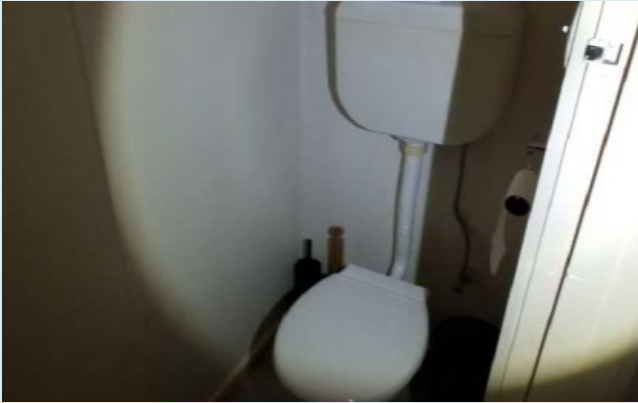
7. Toilet

Requirement Met

The toilet is in working order, connected to the waste system and in a room fit for purpose.

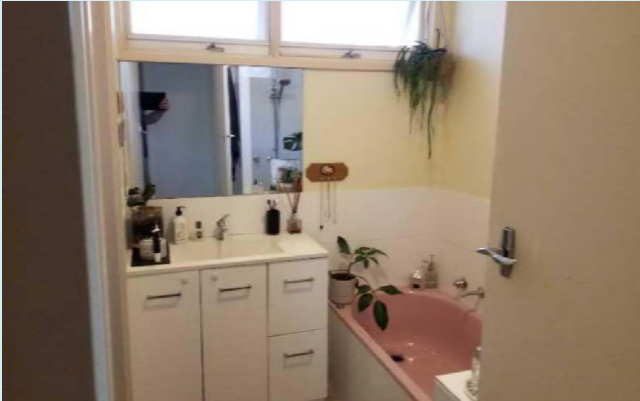
8. Bathroom Facilities

Bathroom Facilities	
Requirement Not Met	Bathroom facilities
Comments	
<p>The bathroom has a wash basin, shower & bath. There is hot and cold water supply to the shower and basin, cold water to the bath but no hot water supply. Requires repair. The showerhead has been tested and achieves a flow rate of 8L/minute.</p>

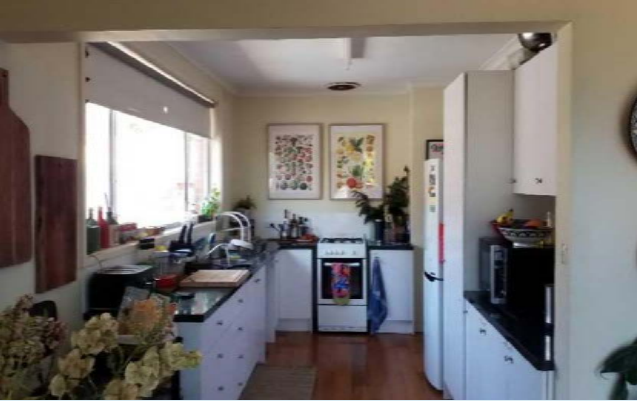
9. Kitchen Facilities

Kitchen Facilities	
Requirement Not Met	Ground Floor
Comments	
<p>The kitchen has a dedicated food preparation area. The kitchen has a sink with hot and cold water supply. The kitchen has a 4 burner gas cooktop in working order, however the ignition bottom is not working and requires repair. The kitchen has an oven in working order.</p>

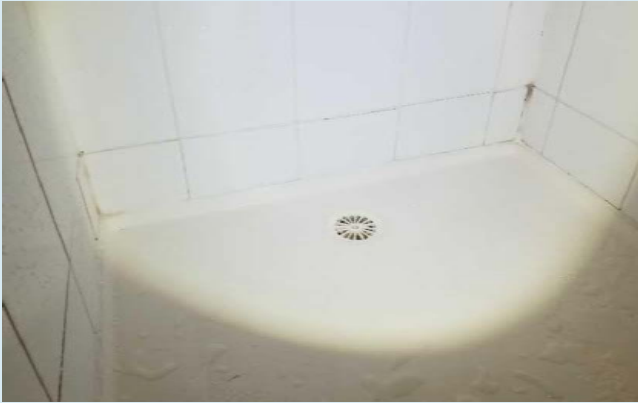
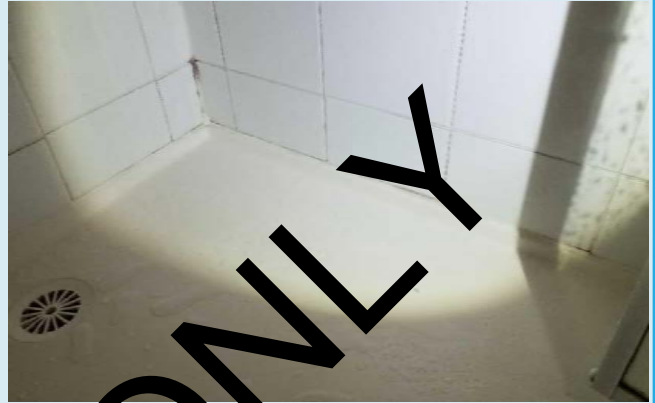
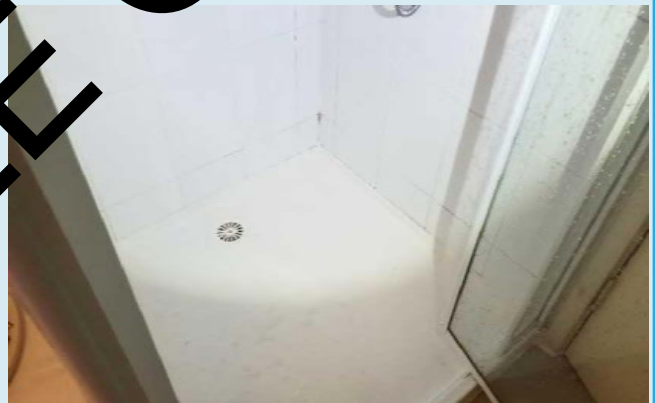
Wet areas

The sealant around the base of the shower is broken and requires re-sealing.

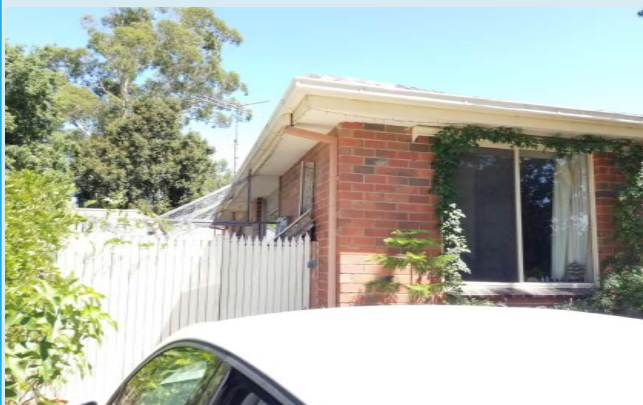
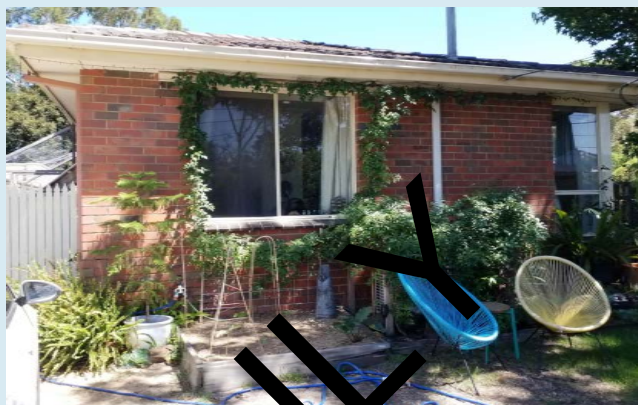
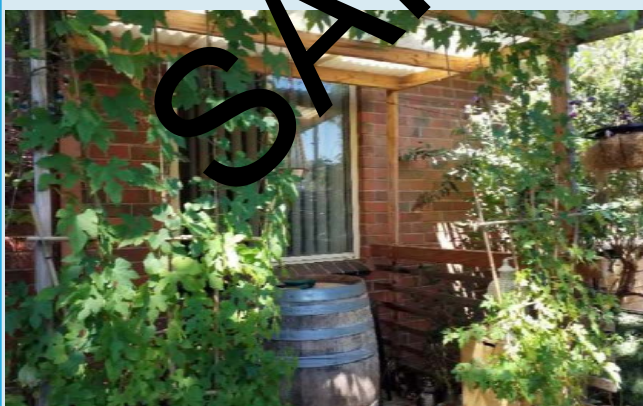
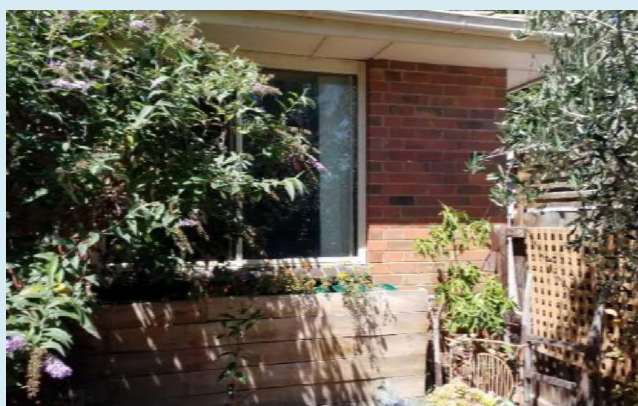
External

The exterior of the dwelling is well maintained and appears structurally sound & weatherproof.

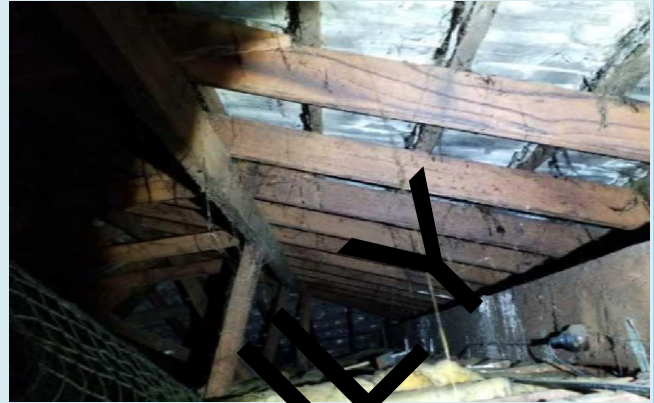
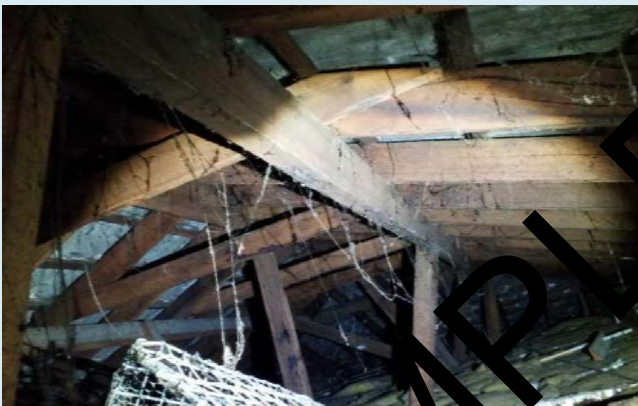
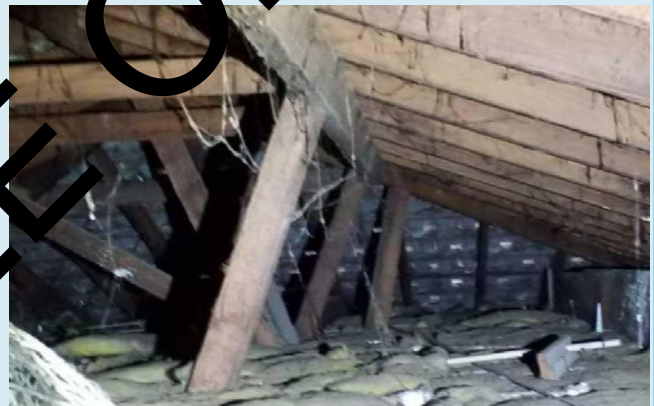
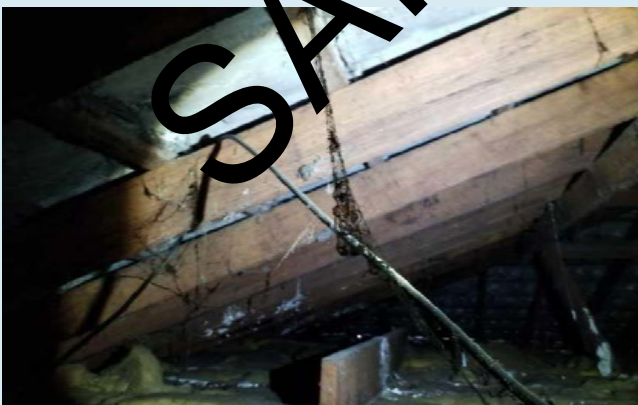
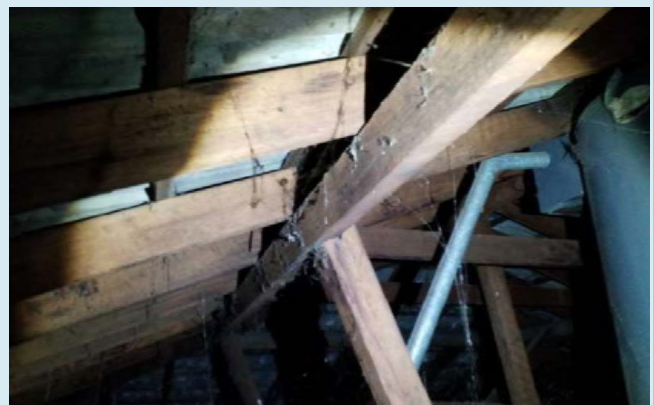
Underside of roof

The underside of the roof appears structurally sound and dry.

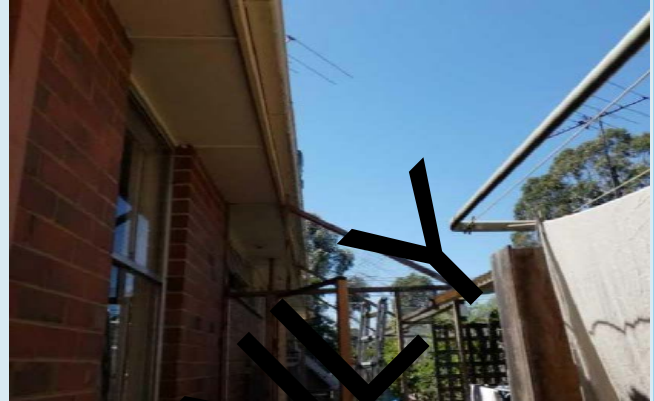
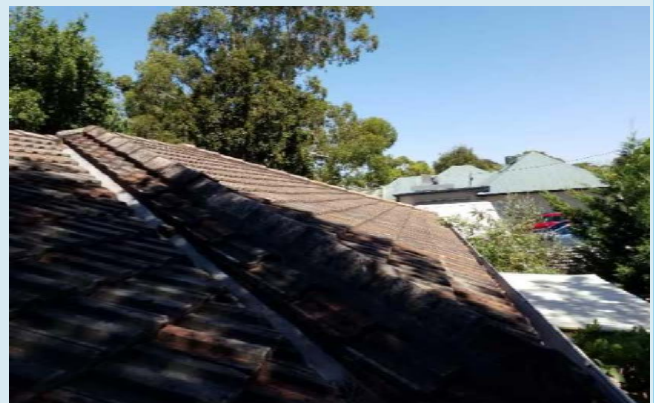
External

The majority of the roof appears structurally sound and waterproof. However the left hand elevation and the rear elevation had no access due to sheds, washing line and a dog cage unable to access those areas of the roof.

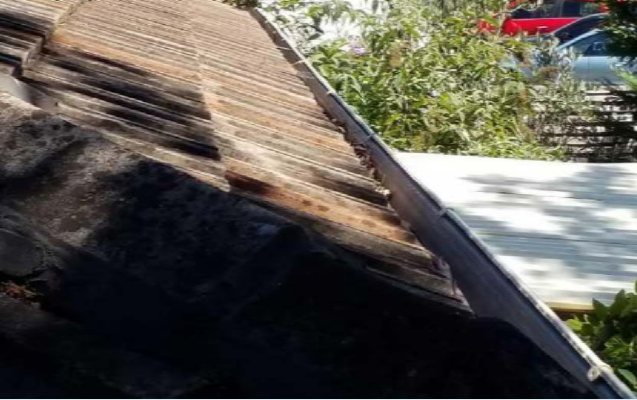
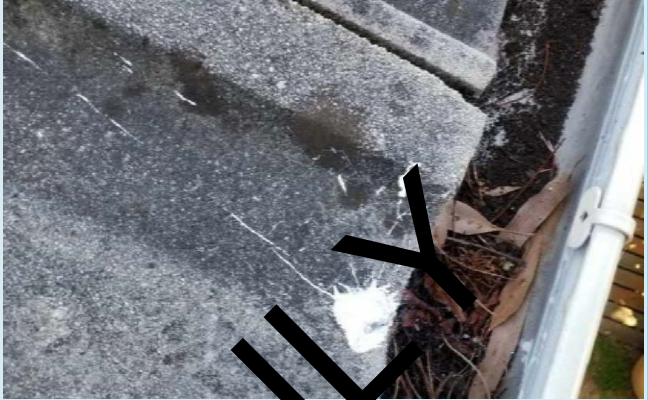
Structural Soundness & Waterproof	
Recommendation	External
Comments	
The guttering requires cleaning.

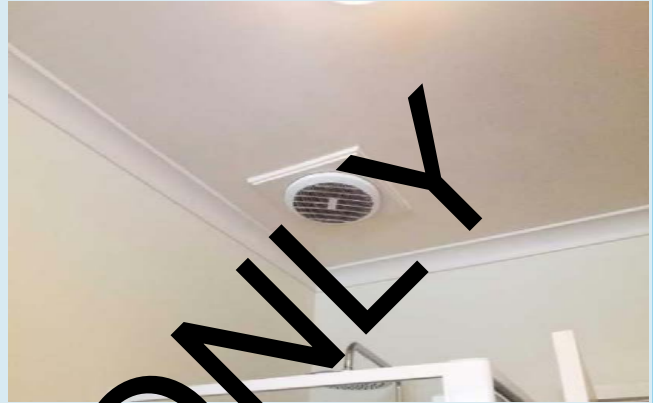
Bathroom

There were no visible signs of mould and dampness in the bathroom.

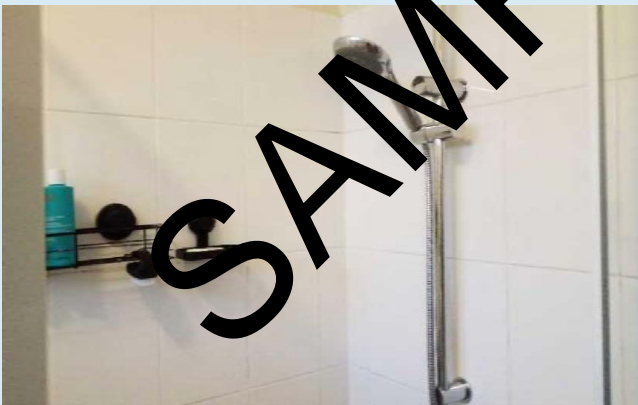
Shower

There were no visible signs of mould and dampness in the shower.

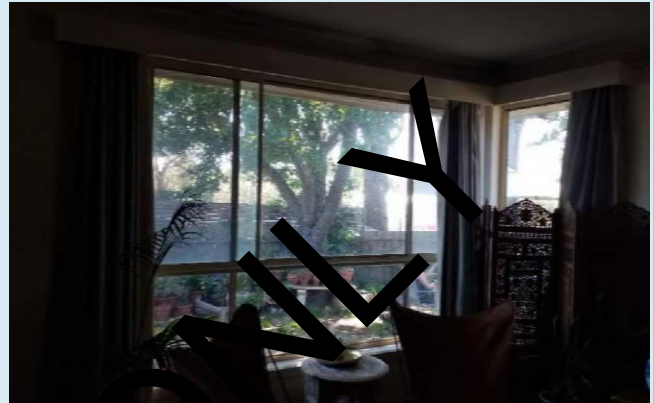
Living Room

Requirement Not Met

The window coverings in the living area are able to be opened and closed, capable of blocking the light but do not provide privacy when the curtains are open during the day.

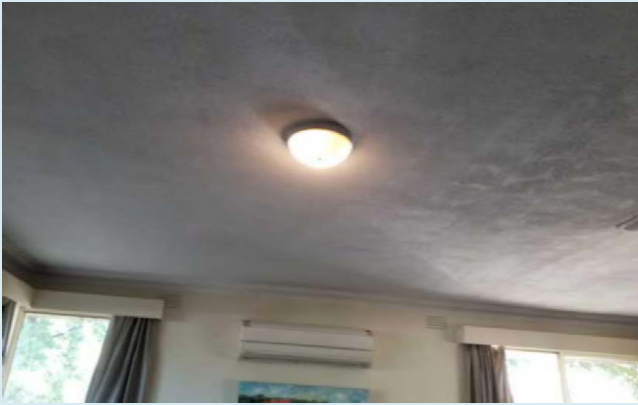
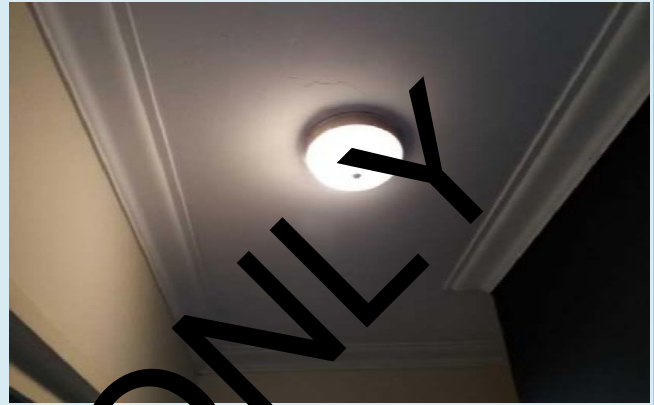
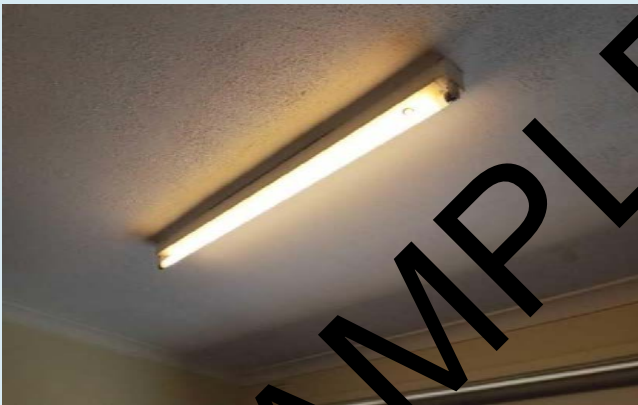
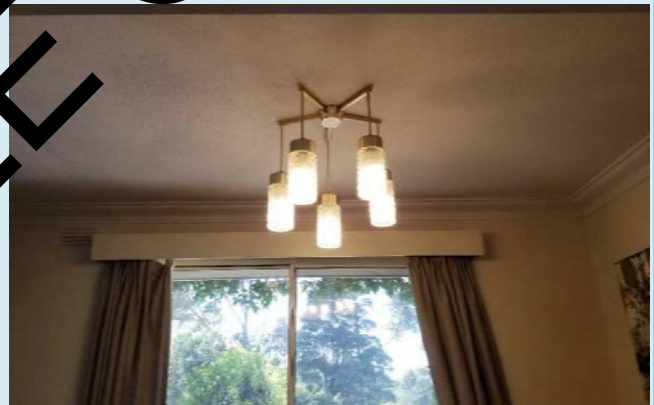
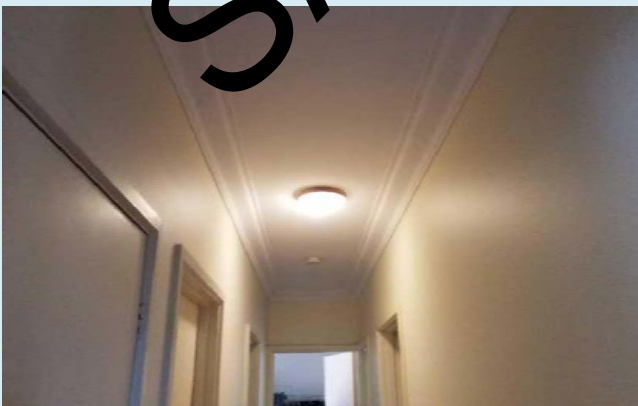
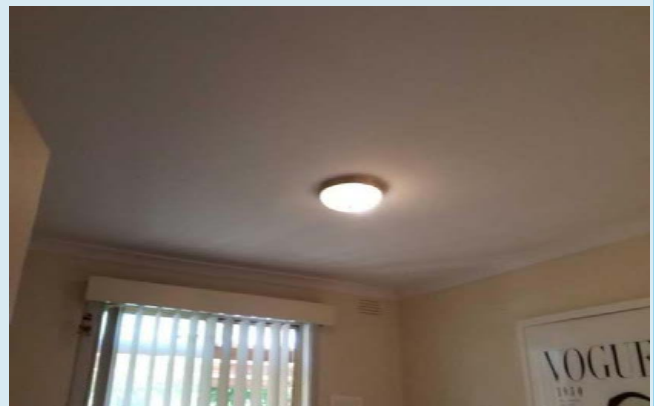
Throughout

All interior rooms and passageway have access to both natural and artificial light.
All bedrooms and bathroom facilities have access to both natural and artificial light.

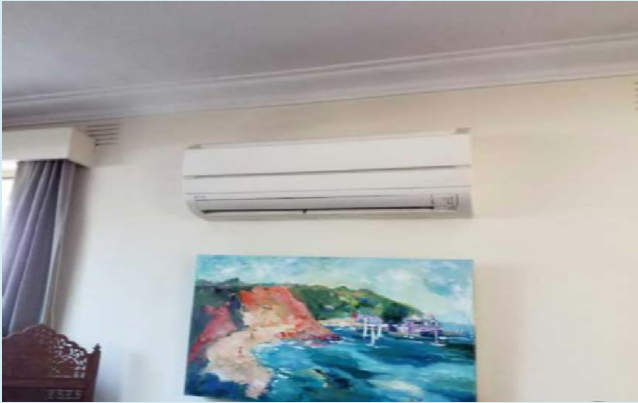
Living Area

A split system air-conditioner is supplied in the living room area for the purpose of heating. Unknown star rating.
